Monitoring Water Quality Response of a Pheasant Branch Creek Tributary to Restoration of the Acker Farm

August 2019

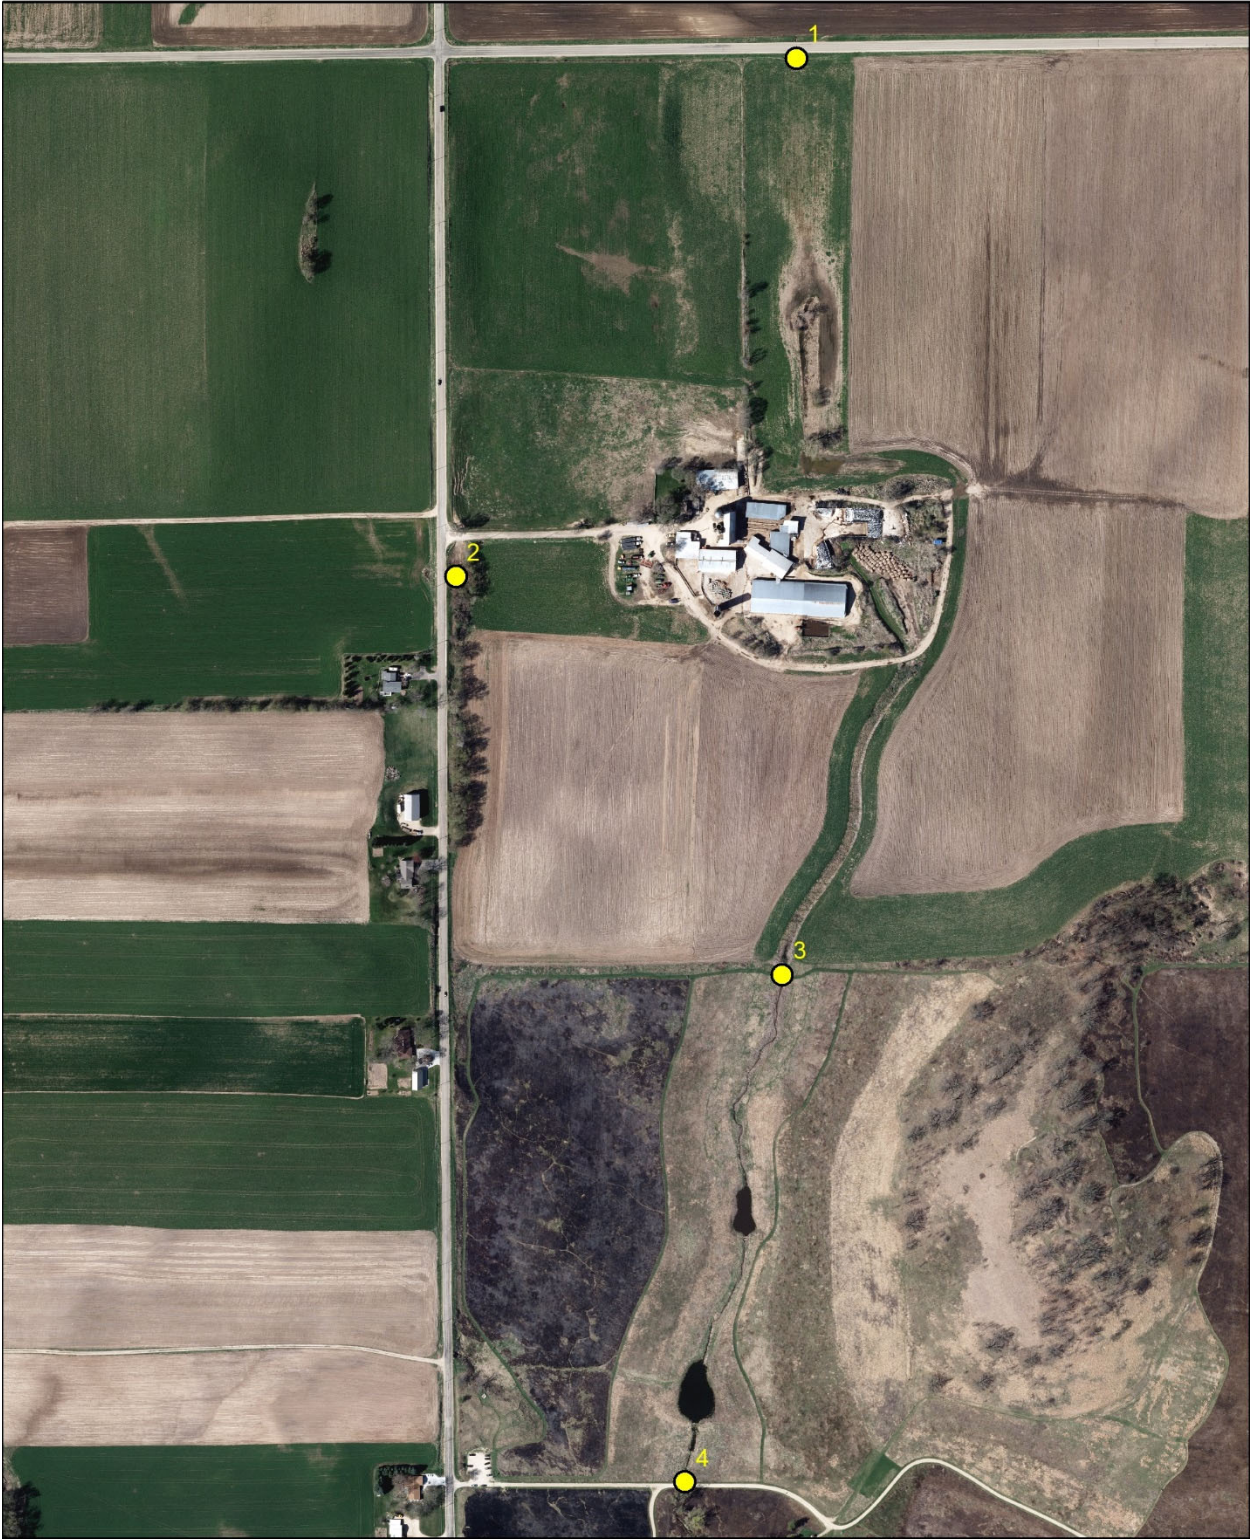
Acker Farm Water Quality Sites

● Sample Sites
2017 Aerial Photograph

Discharge is estimated by the water quality sample collector by measuring cross-sectional area of flow with a marked rod and by estimating velocity by timing a floating object across a measured length of channel. Stream stage is recorded at 15-minute intervals with an Onset HOBO pressure transducer at sites 3 and 4. Stage is converted to discharge with a rating curve at site 3 and with a culvert hydraulic equation at site 4. A tipping-bucket rain gauge is located at site 3. Pressure transducer and rain gauge installation and maintenance and rating curve and load estimation are managed by Dane County staff.
